# Bathymetric Surveys at Highway Bridges Crossing the Missouri and Mississippi Rivers near St. Louis, Missouri, 2010

Scientific Investigations Report 2011–5170

By Richard J. Huizinga

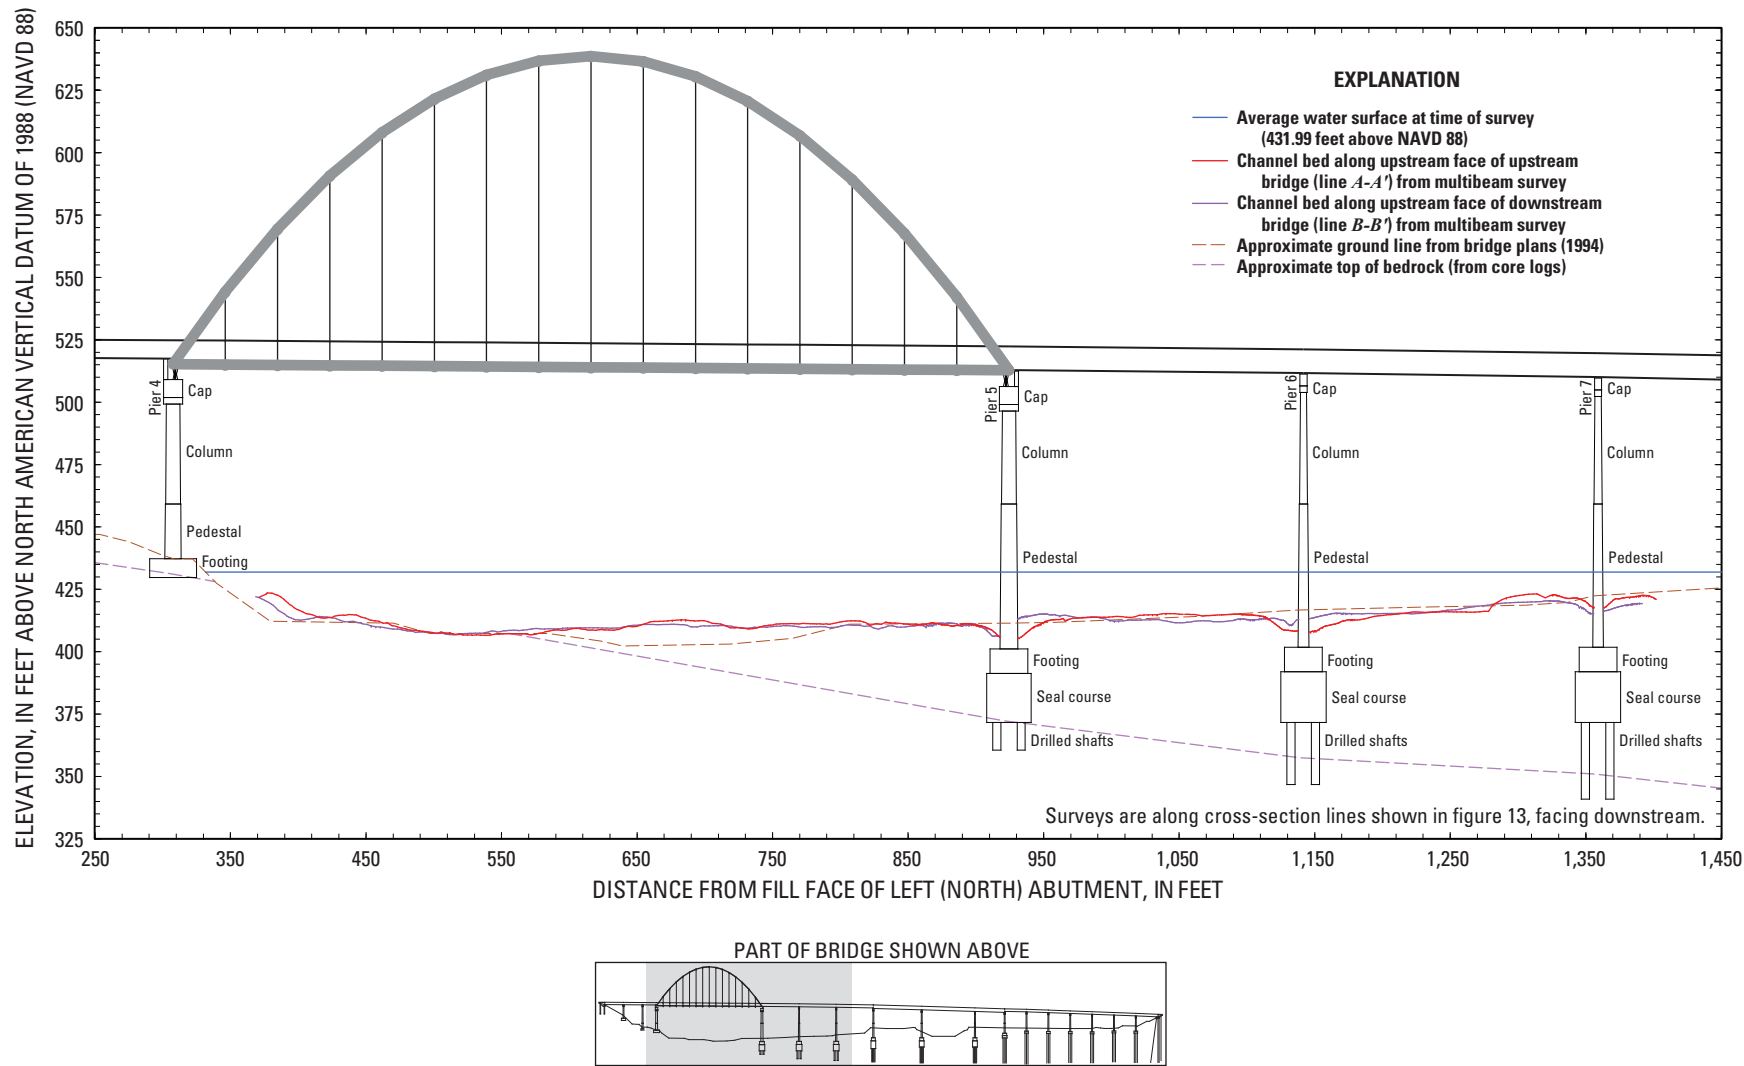
Information from bridge plans indicates that both bridges of structure A5585 are exactly the same in cross section for the part of the bridges across the main channel, which permits the cross-section data for each bridge to be examined together (fig. 15). The main channel piers of both bridges of structure A5585 are founded on shafts drilled 11 ft into bedrock (fig. 15; table 6). Depth of bed material between bedrock and the bottom of the various scour holes at dual bridge structure A5585 ranges from 33 to 67 ft because of the sloping bedrock in the area (fig. 15; table 6). The minimum elevation in each of the scour holes is substantially higher than the bottom of the seal course elevation at each pier of 371.62 ft (fig. 15; table 6). The surveyed bed is not substantially different from the original ground line from bridge plans at the time of construction in 1994 (fig. 15).

**Figure 15.** Key features, substructural and superstructural details, and surveyed channel bed along the upstream face of each bridge of dual bridge structure A5585 on State Highway 364 over the Missouri River near St. Louis, Missouri.

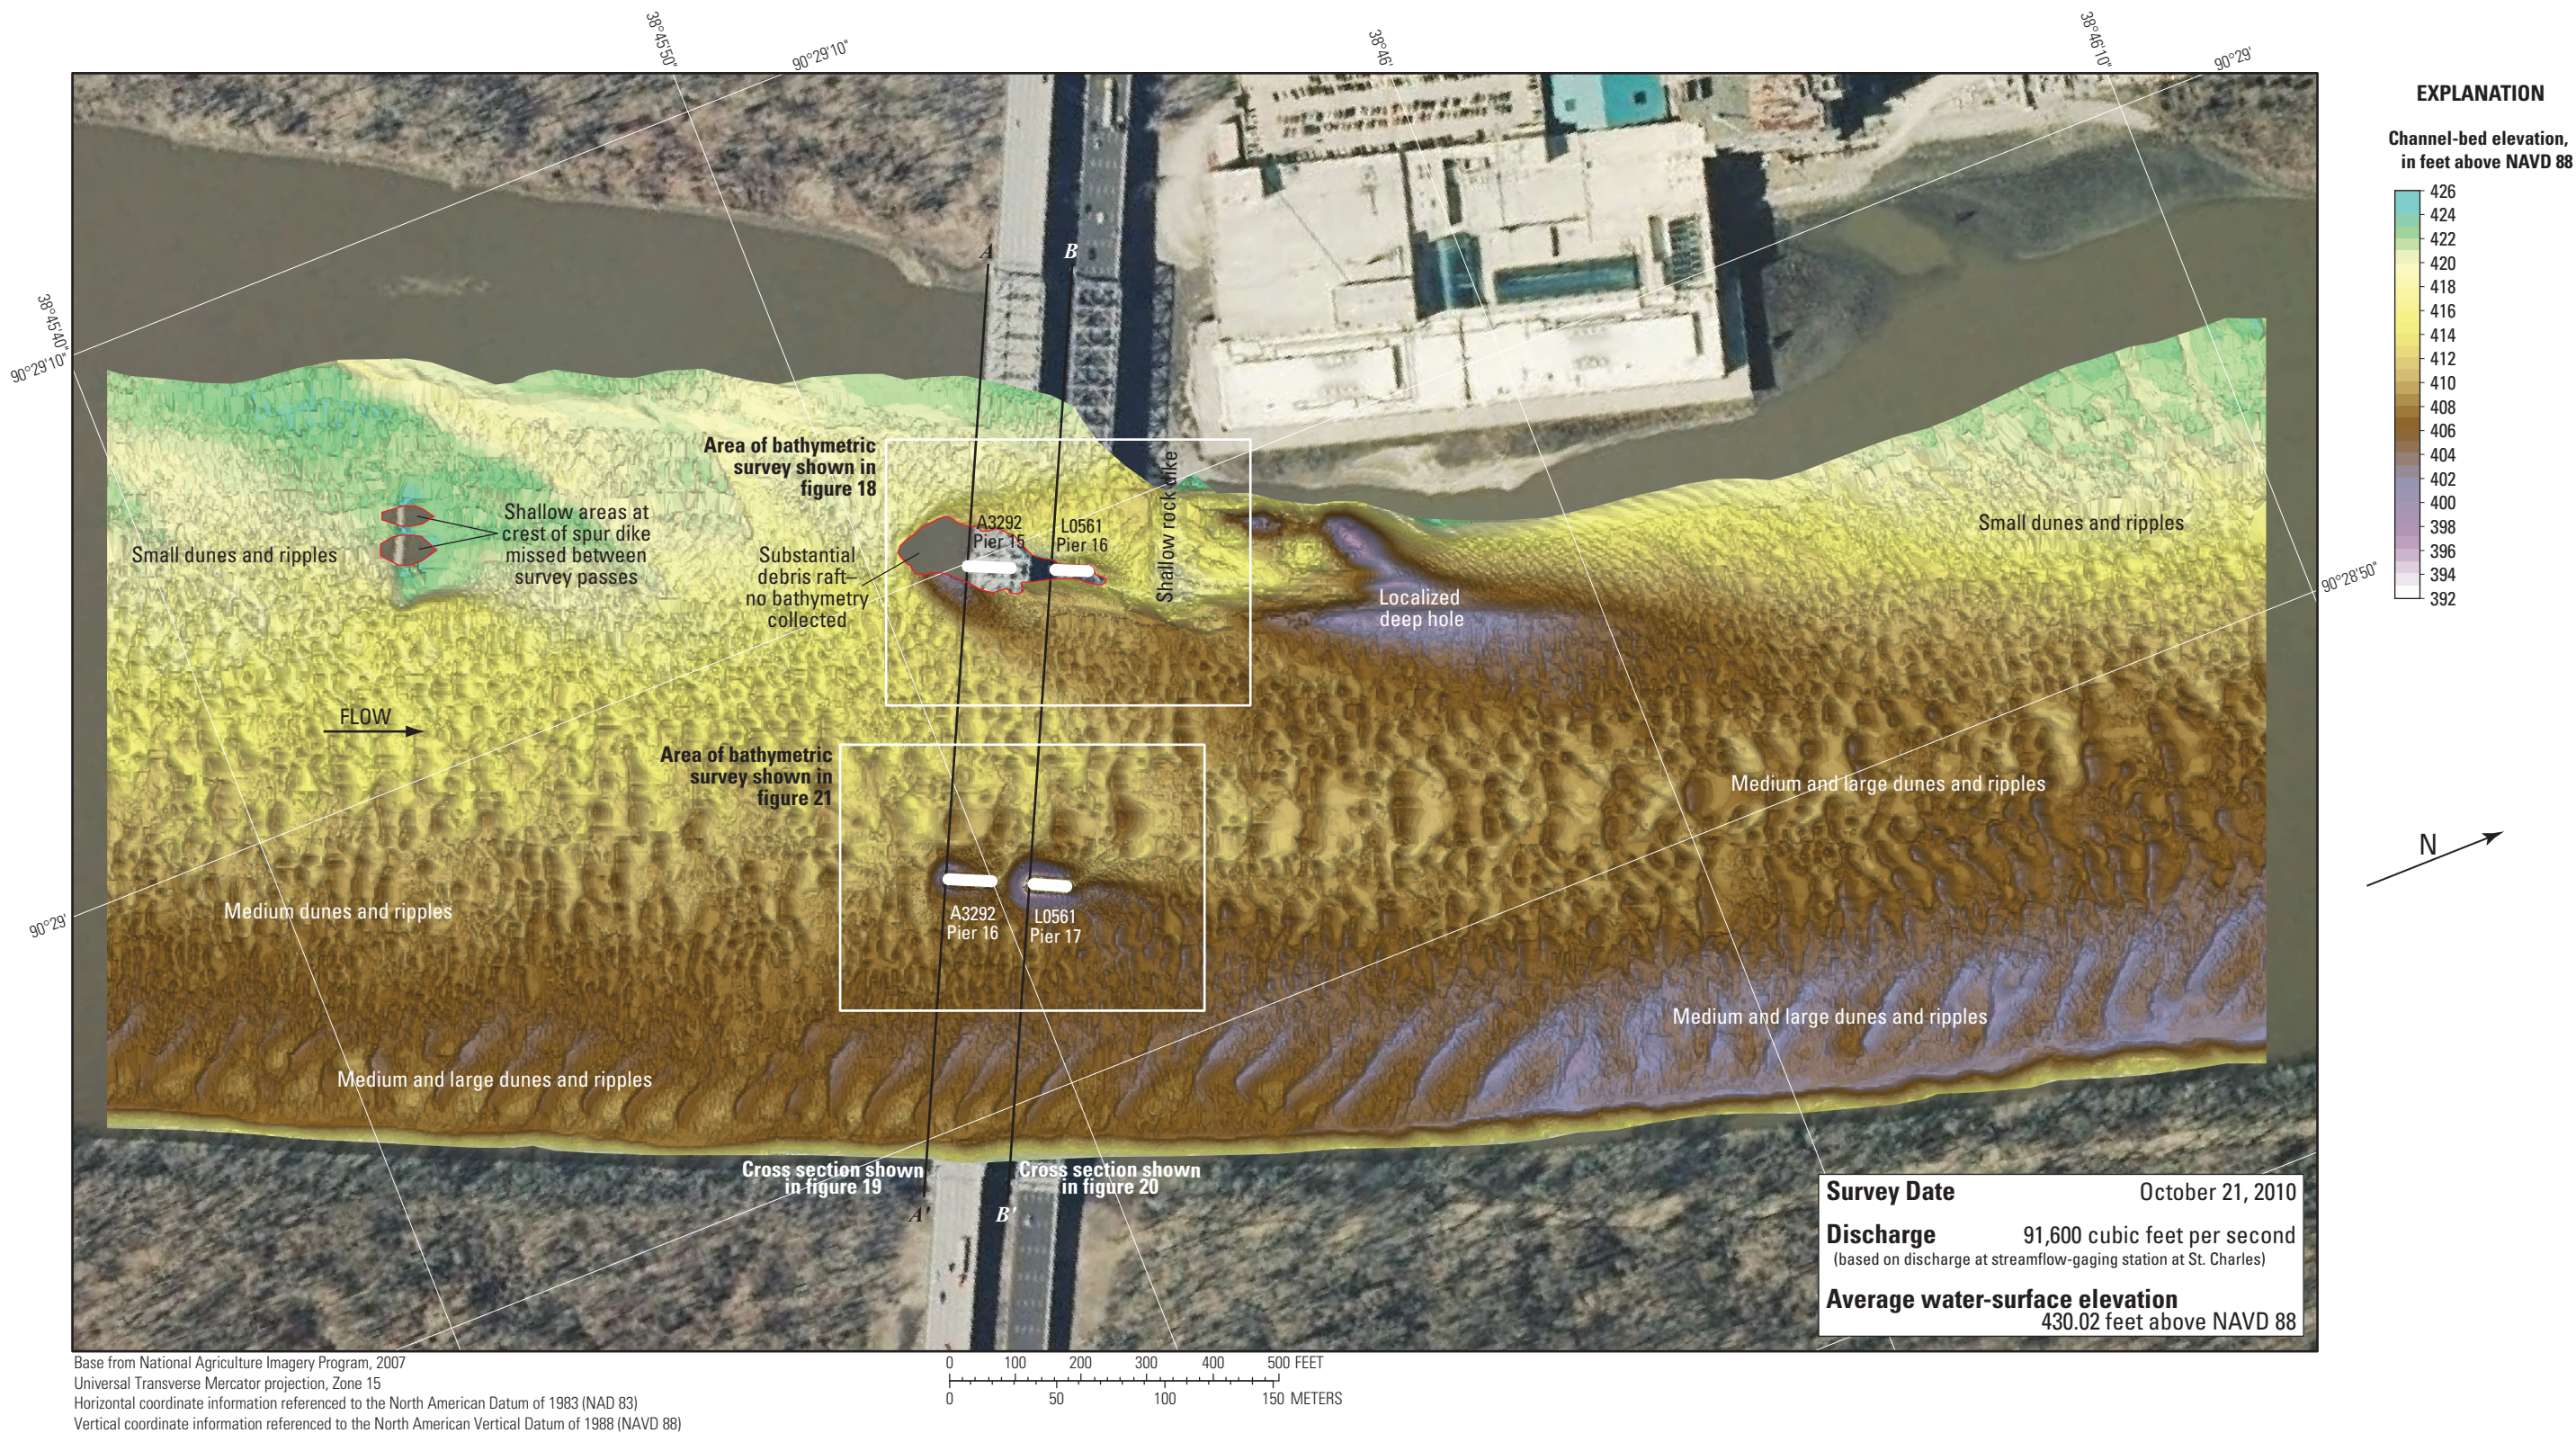
The survey area was about 3,280 ft long and about 1,200 ft wide, extending from the shallow area between spur dikes on the left to the right bank in the main channel (fig. 17). The upstream end of the survey area was about 1,370 ft upstream from the centerline between structures A3292 and L0561 (figs. 16, 17). The channel-bed elevations ranged from about 403 to 420 ft for most of the surveyed area (5 to 95 percentile range of the bathymetric data, fig. 17). A deep thalweg on the right (south) bank on the upstream end of the surveyed area was about 10 ft deeper than the channel bed in the middle of the channel (fig. 17). The channel and thalweg deepened downstream from the bridges (fig. 17), likely because of the contraction of the channel caused by the building on the left bank downstream from the bridges. In the vicinity of the rock spur dike on the upstream left (north) side, deposits reached an elevation of about 424 ft (fig. 17). Similar to the two upstream sites (structures A4017 and J1000, and dual bridge structure A5585), numerous medium and small dunes and ripples were detected throughout the channel, and larger dune features were detected in the channel thalweg downstream from the bridges

(fig. 17). A localized deep scour hole at the end of what appears to be a shallow spur dike between the downstream bridge and the building on the left bank had a minimum elevation of about 397 ft (fig. 17).

Figure 17. Bathymetric survey of the Missouri River channel in the vicinity of structures A3292 and L0561 on Interstate 70 near St. Louis, Missouri.

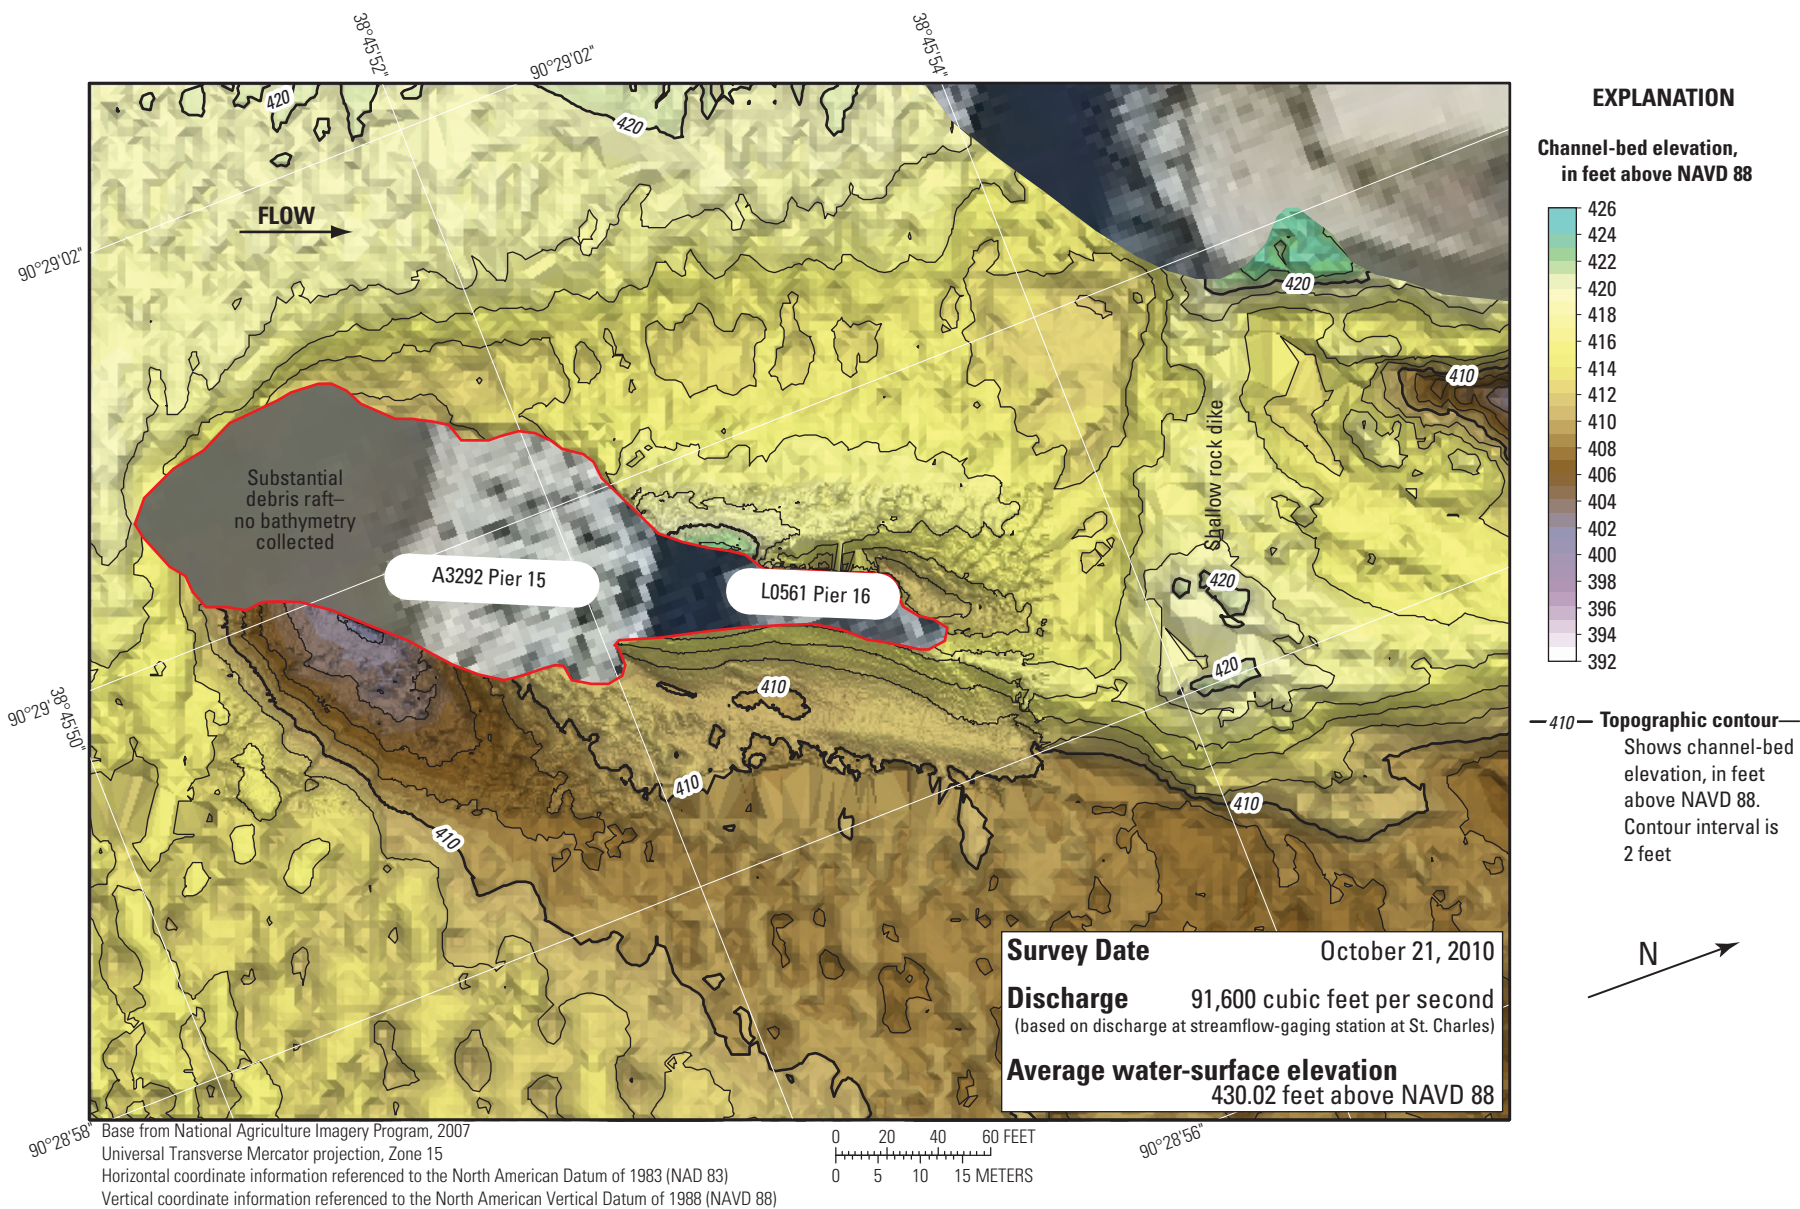
**Figure 18.** Bathymetric survey of the Missouri River channel in the vicinity of the left main channel piers of structures A3292 and L0561 on Interstate 70 near St. Louis, Missouri.

In the vicinity of the left main channel piers (pier 15 of upstream structure A3292 and pier 16 of downstream structure L0561; fig. 18), local scour was difficult to determine because a substantial debris raft at the nose of pier 15 of upstream structure A3292 made it impossible to acquire bathymetry data in the vicinity of the left main channel piers. A local scour hole caused by the debris raft had a minimum measured elevation of approximately 402 ft near the upstream nose of pier 15 of upstream structure A3292 (figs. 18, 19), about 17 ft below the average channel bed immediately upstream from the pile. The true minimum elevation of the scour hole was not measured, and likely is lower than the measured minimum of approximately 402 ft; however, based on the size and shape of the observable part of the scour hole, the true minimum elevation in the hole likely was well above the bottom of the seal course elevation of pier 15 of 378.00 ft (fig. 19; table 6). Information from bridge plans indicates that pier 15 of upstream structure A3292 is founded on shafts drilled approximately 16 ft in bedrock (table 6), with about 52 ft of bed material between the bottom of the scour hole and bedrock near the upstream pier (fig. 19). Pier 16 of downstream structure L0561 is founded on a caisson on bedrock (fig. 20; table 6), and the bottom of the local scour hole near this pier is about 59 ft above the bottom of the caisson and bedrock. It is likely that the shallow spur dike between the downstream bridge and the casino on the left bank limits the scour that can occur near the downstream pier.

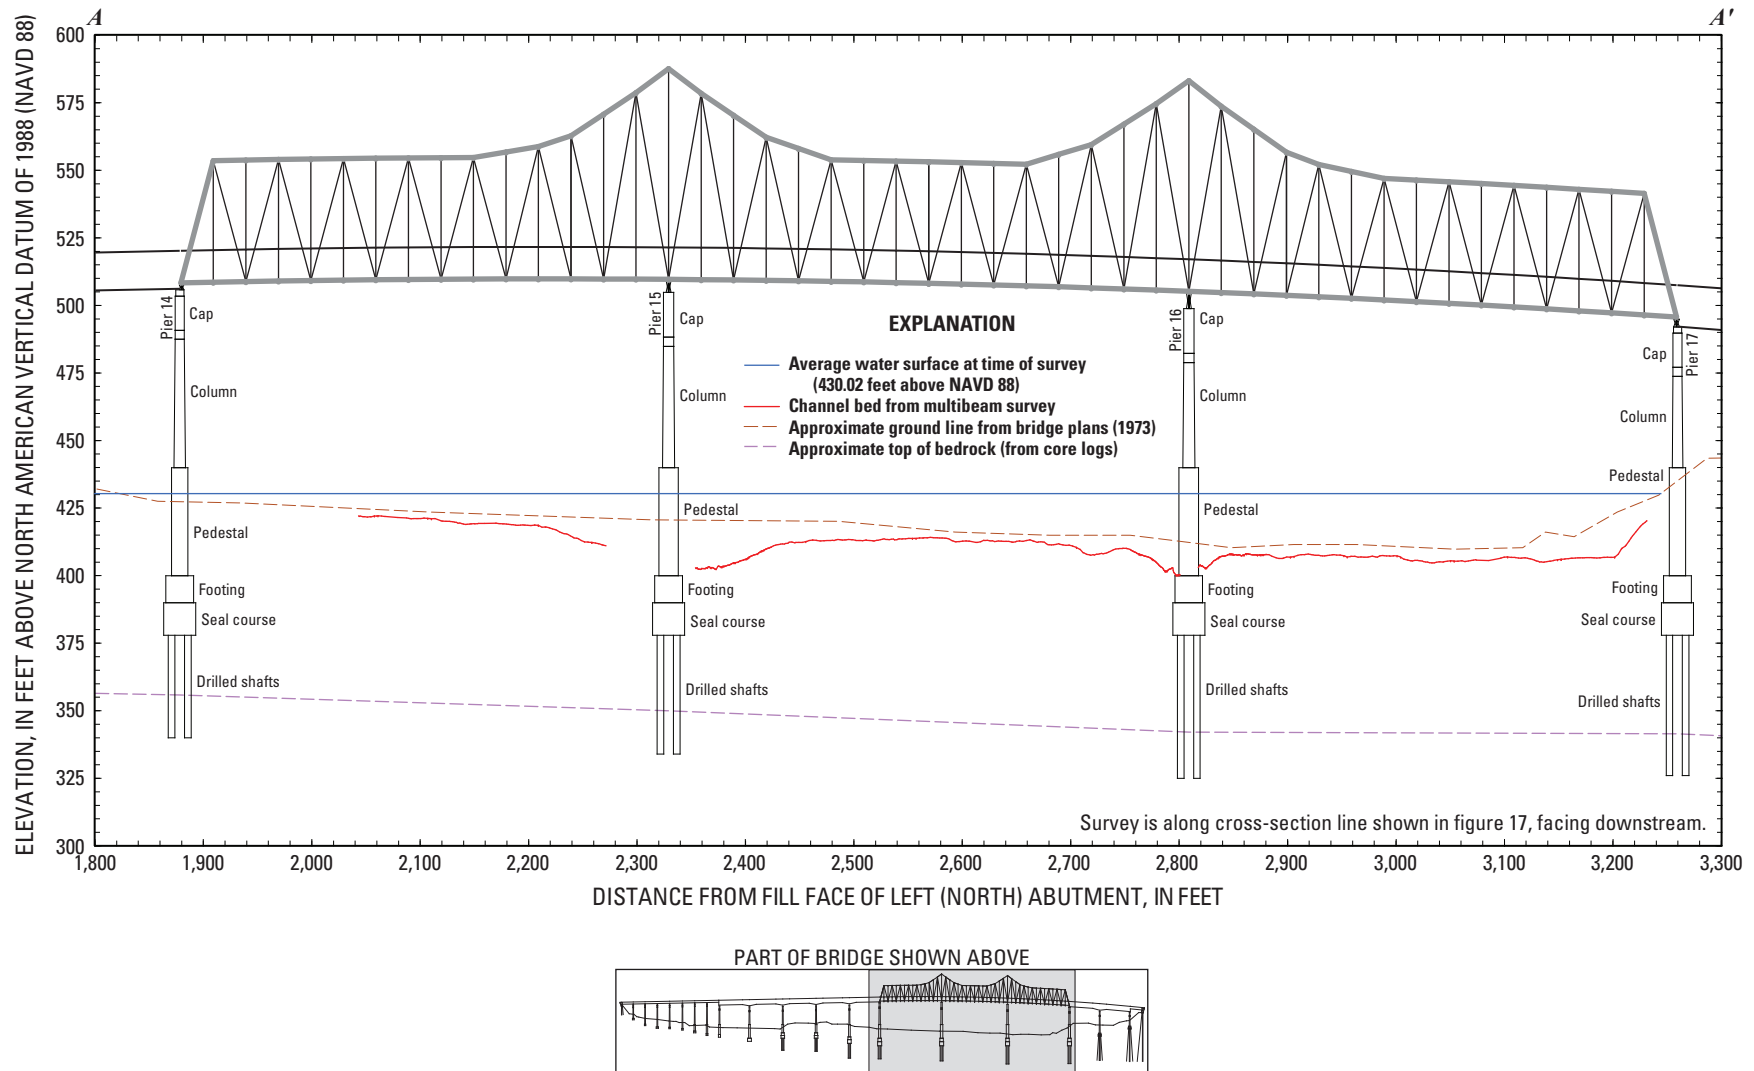
**Figure 19.** Key features, substructural and superstructural details, and surveyed channel bed of structure A3292 on Interstate 70 over the Missouri River near St. Louis, Missouri.

The surveyed bed throughout the channel is approximately 5 ft lower than the original ground line from bridge plans at the time of construction (1973) at upstream structure A3292 (fig. 19). The surveyed bed is approximately 15 ft lower than the original ground line from bridge plans at construction (1955) at downstream structure L0561 throughout the channel (fig. 20). These changes in bed elevation indicate a decrease in the overall bed elevation at this site with time, likely caused in part by the constriction near the building on the left bank.

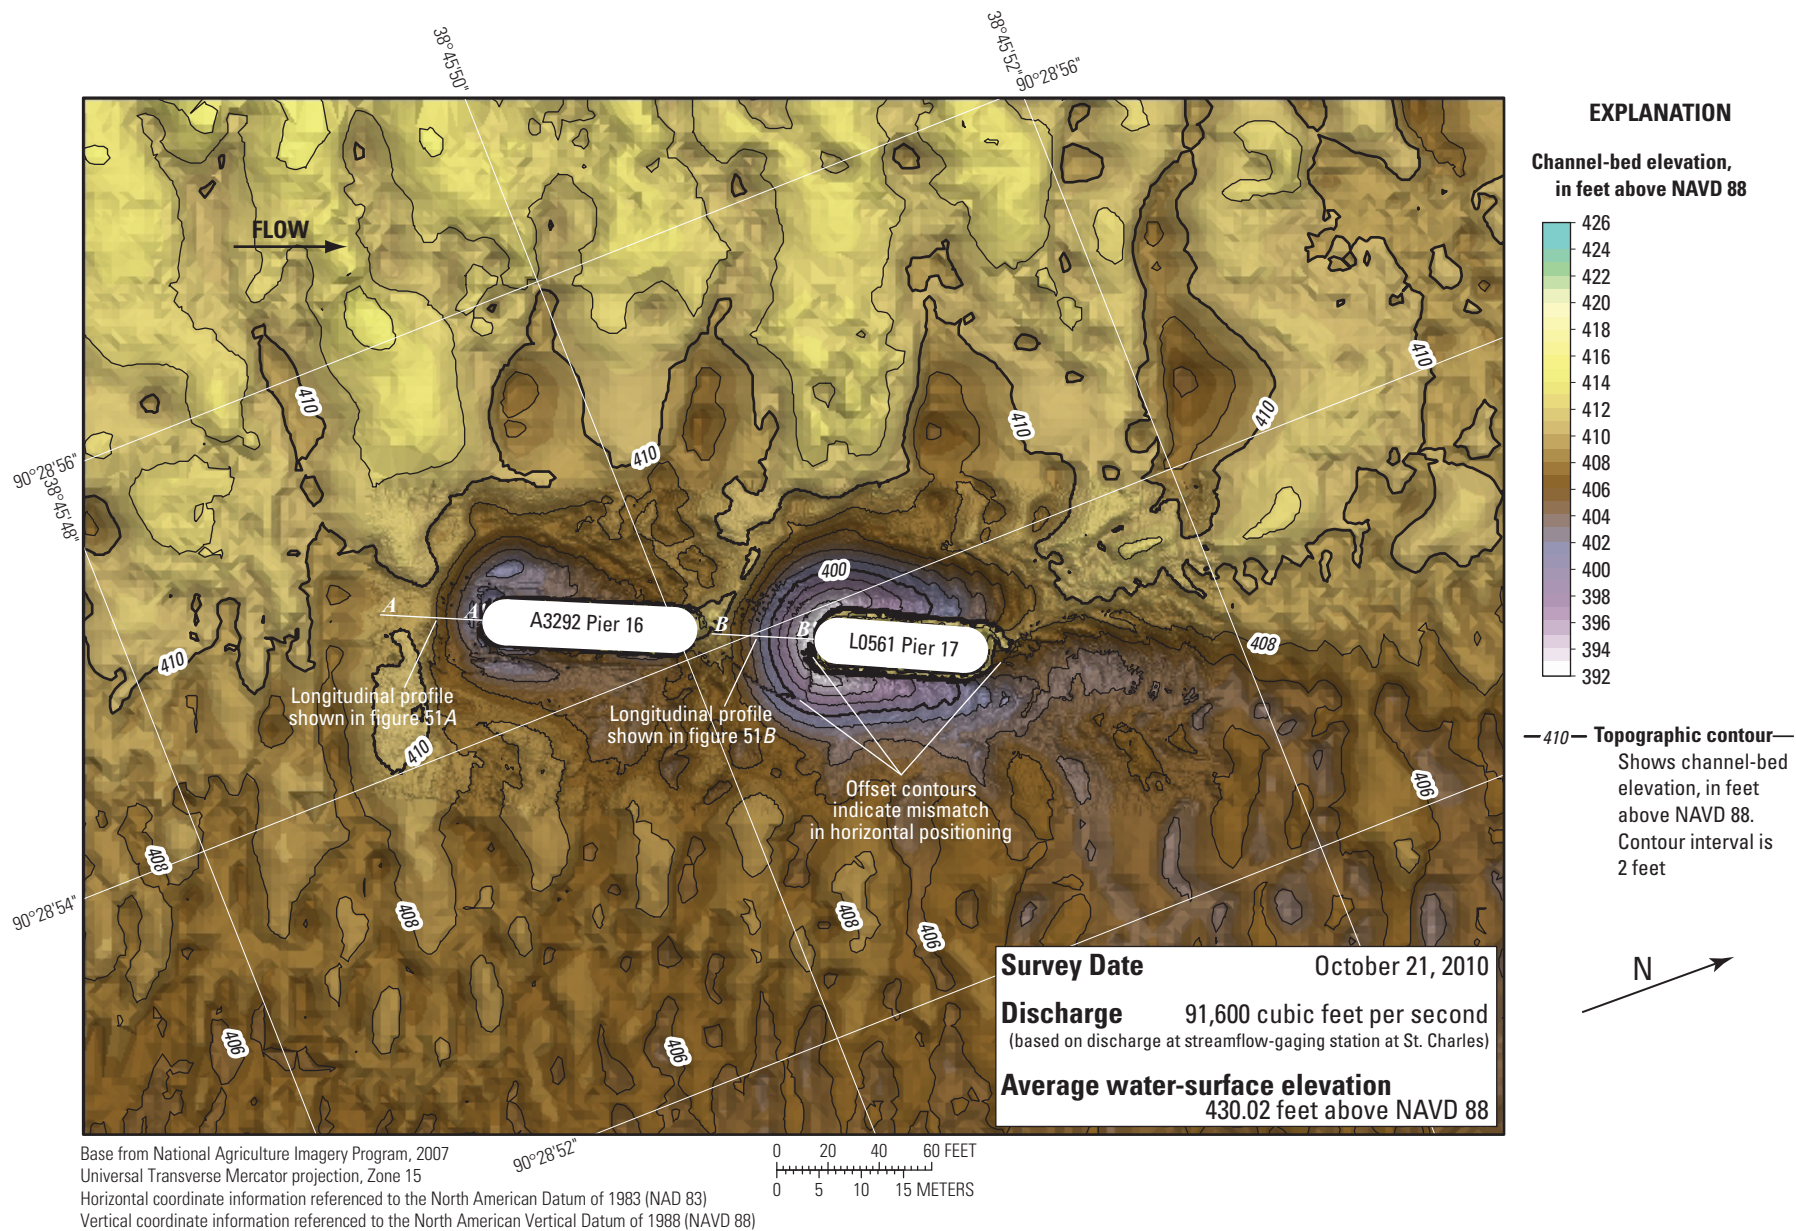
Scour holes were present in the vicinity of the right main channel piers (fig. 21) of structures A3292 and L0561. The scour hole at upstream pier 16 had a minimum elevation of about 402 ft (fig. 21; table 6), about 8 ft below the average channel bed immediately upstream from the pier, whereas the scour hole at downstream pier 17 had a minimum elevation of about 393 ft (fig. 21; table 6), about 15 ft below the average channel bed immediately upstream from the pier. Information from bridge plans indicates that pier 16 of upstream structure A3292 is founded on shafts drilled 17 ft into bedrock, with about 60 ft of bed material between the bottom of the scour hole and bedrock (fig. 19; table 6). Pier 17 of structure L0561 is founded on a caisson on bedrock, with about 50 ft of bed material between the bottom of the scour hole and bedrock (fig. 20; table 6).

An offset in the survey contours near pier 17 of downstream structure L0561 (fig. 21) indicates a mismatch of the horizontal position on adjacent survey lines. This discrepancy in horizontal position is a result of losing GPS signal where the survey lines passed under the bridge. Normally, all such mismatches in horizontal position are minimized or completely removed by post-processing the navigation data with POS-Pac™ MMS™; however, the mismatch was not completely removed at this location. It was observed during a substantial part of the survey at this site, the satellite configuration was such that a navigation solution with a higher positional dilution of precision (PDOP) was established for the on-board GPS system, causing what is known as a “float” RTK solution rather than a “fixed” RTK solution. Whereas the positional accuracy of a “fixed” RTK solution is on the order of 0.03 to 0.07 ft, a “float” RTK solution typically has a positional accuracy of 0.3 to 0.7 ft; when under the bridge, the

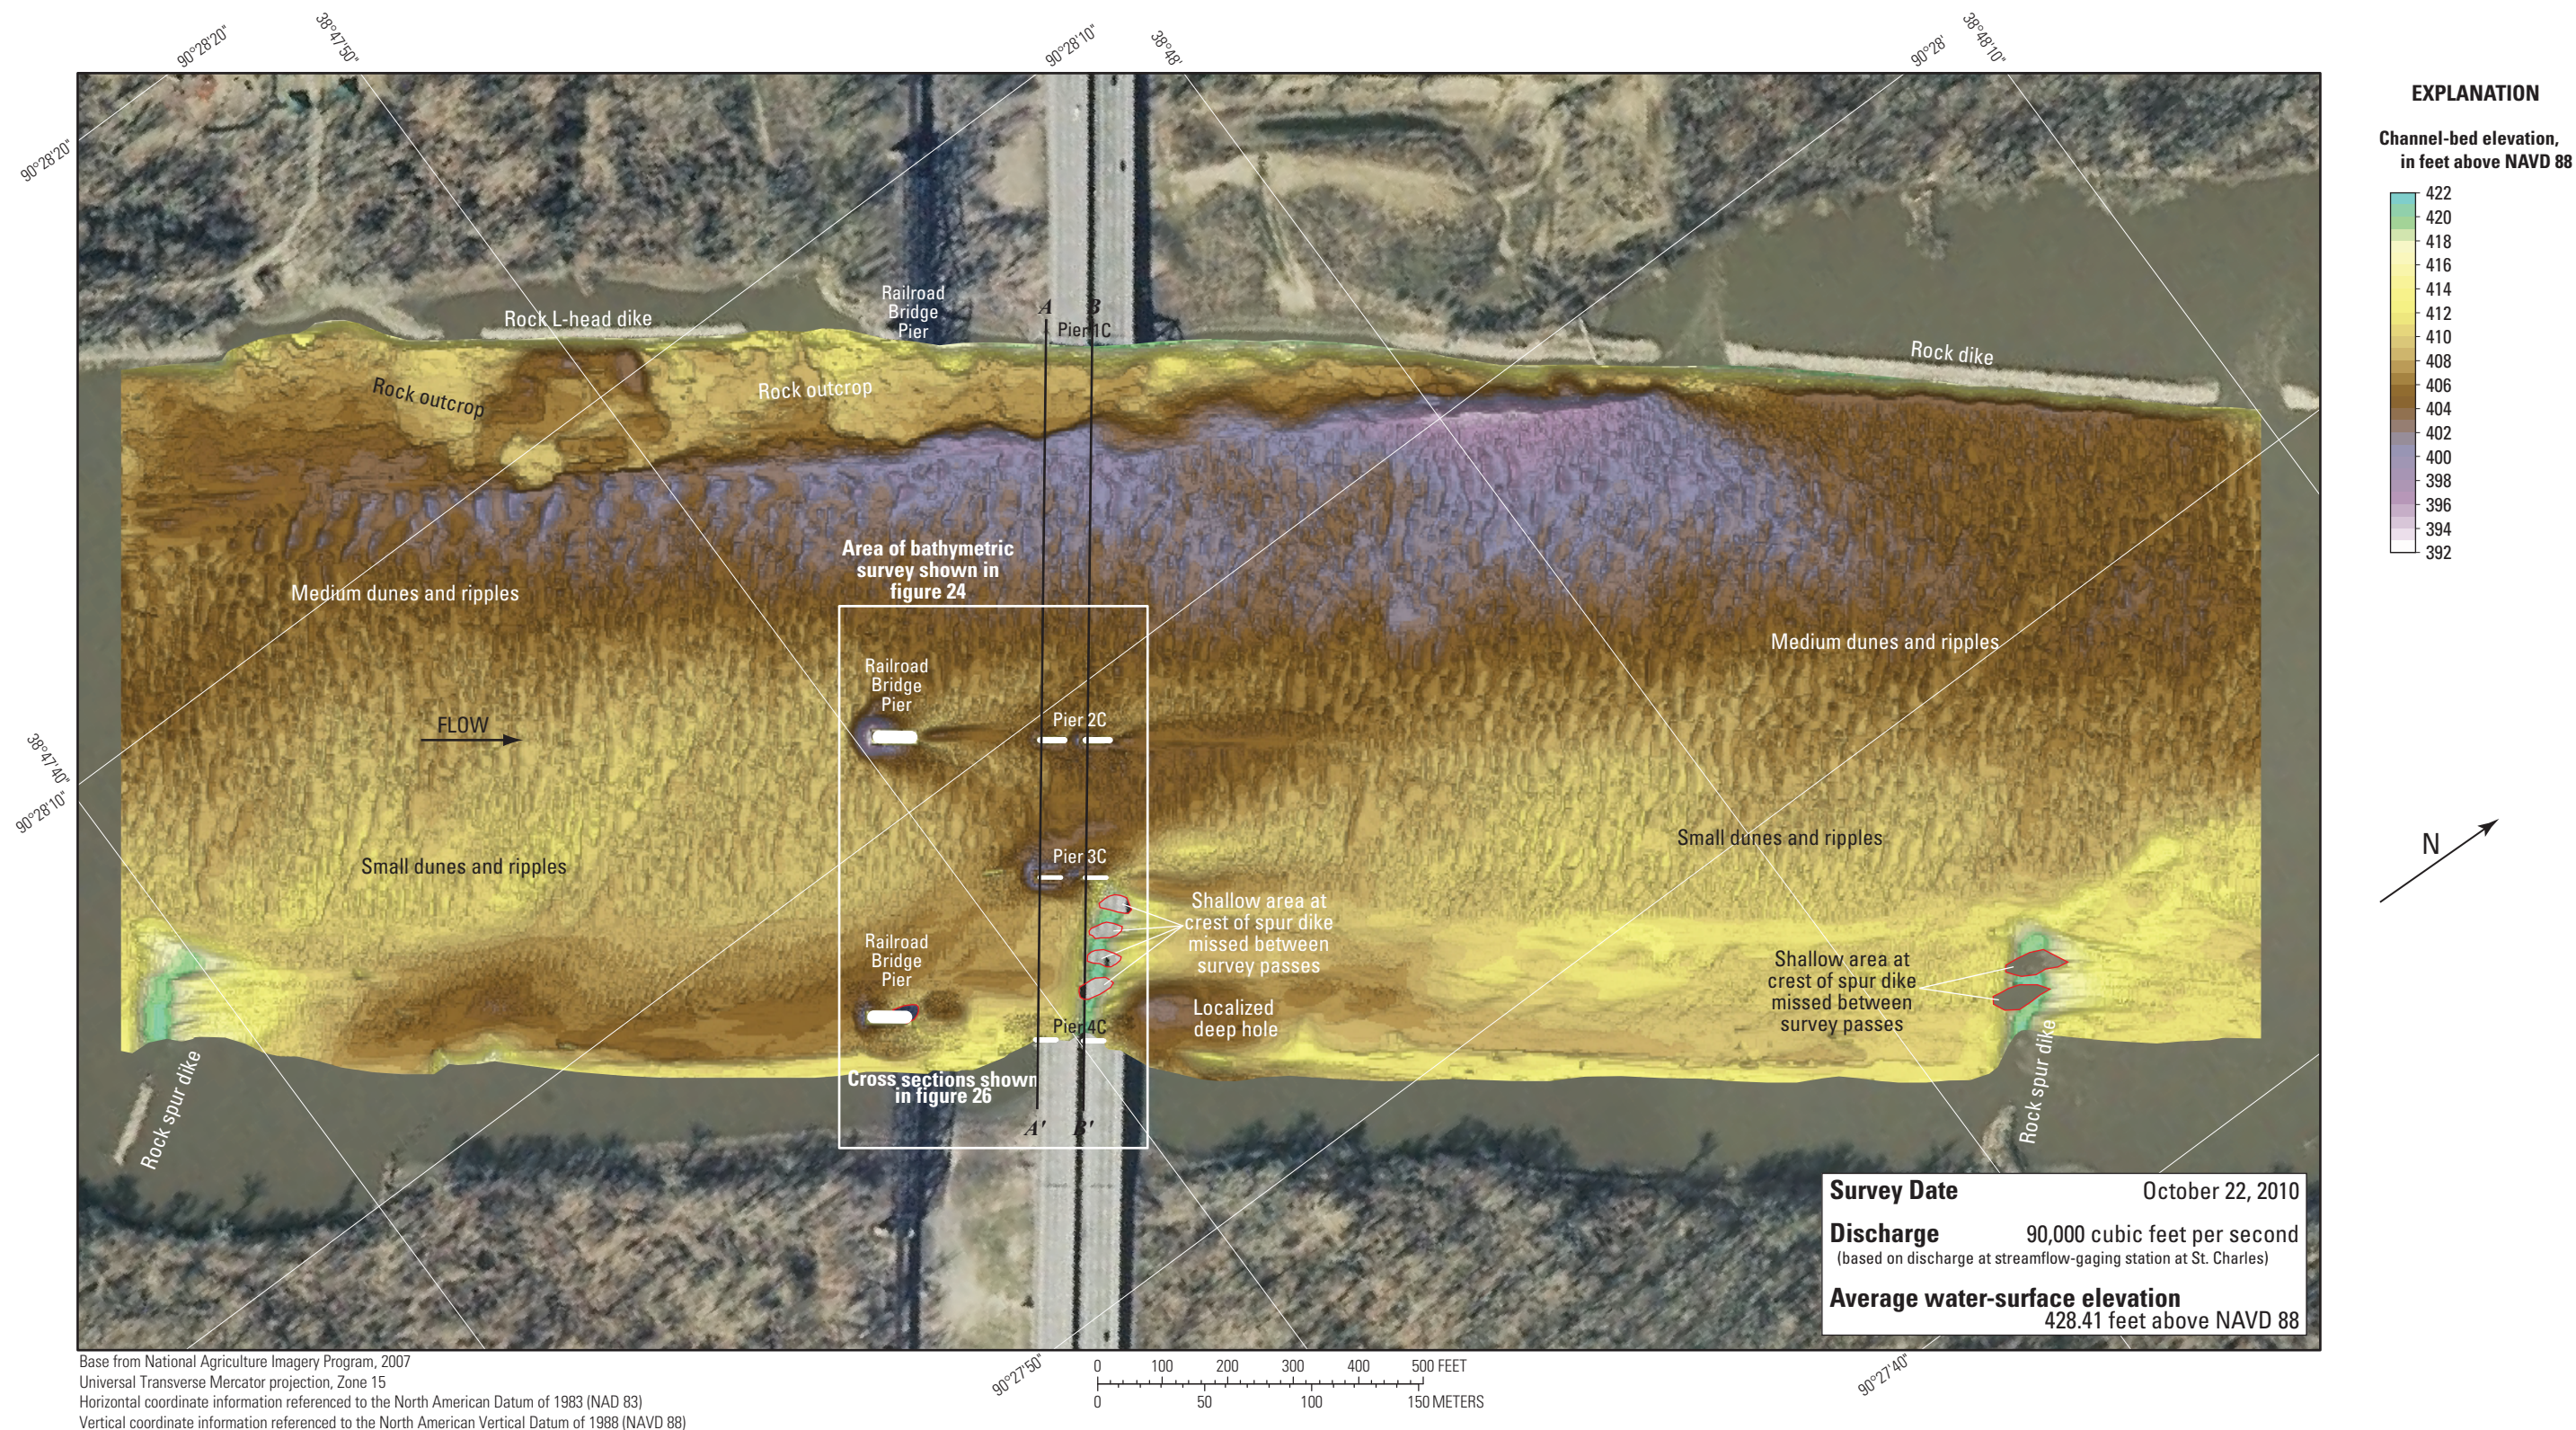
The survey area was about 3,280 ft long and averaged about 1,100 ft wide, extending from rock dikes and the channel bank on the left to shallow areas on the right in the main channel (fig. 23). The upstream end of the survey area was about 1,480 ft upstream from the centerline of structure A4557 (figs. 22, 23). The channel-bed elevations ranged from about 402 to 413 ft for most of the surveyed area (5 to 95 percentile range of the bathymetric data), except for a localized deep area along the toe of a rock outcrop along the left side of the channel, which had a minimum elevation of approximately 395 ft (fig. 23; table 5). The rock outcrop appears to extend from a point upstream from the bridge to the rock dikes downstream from the bridge (fig. 23).

from the pier. There essentially was no scour hole around either upstream or downstream pier 4C (fig. 24); however, the spur dike adjacent to these piers caused a local deep hole that reached a minimum elevation of about 403 ft (fig. 23; table 6). These piers essentially are embedded in the rock of the dike, which will limit or prevent additional scour near both of them. Material from the toe of the spur dike extends to downstream pier 3C, and may limit scour near that pier as well; however, a point cloud visualization of the multibeam depth points obtained during the survey clearly shows the exposed footing of upstream pier 3C (fig. 25).

Figure 23. Bathymetric survey of the Missouri River channel in the vicinity of dual bridge structure A4557 on State Highway 370 near St. Louis, Missouri.

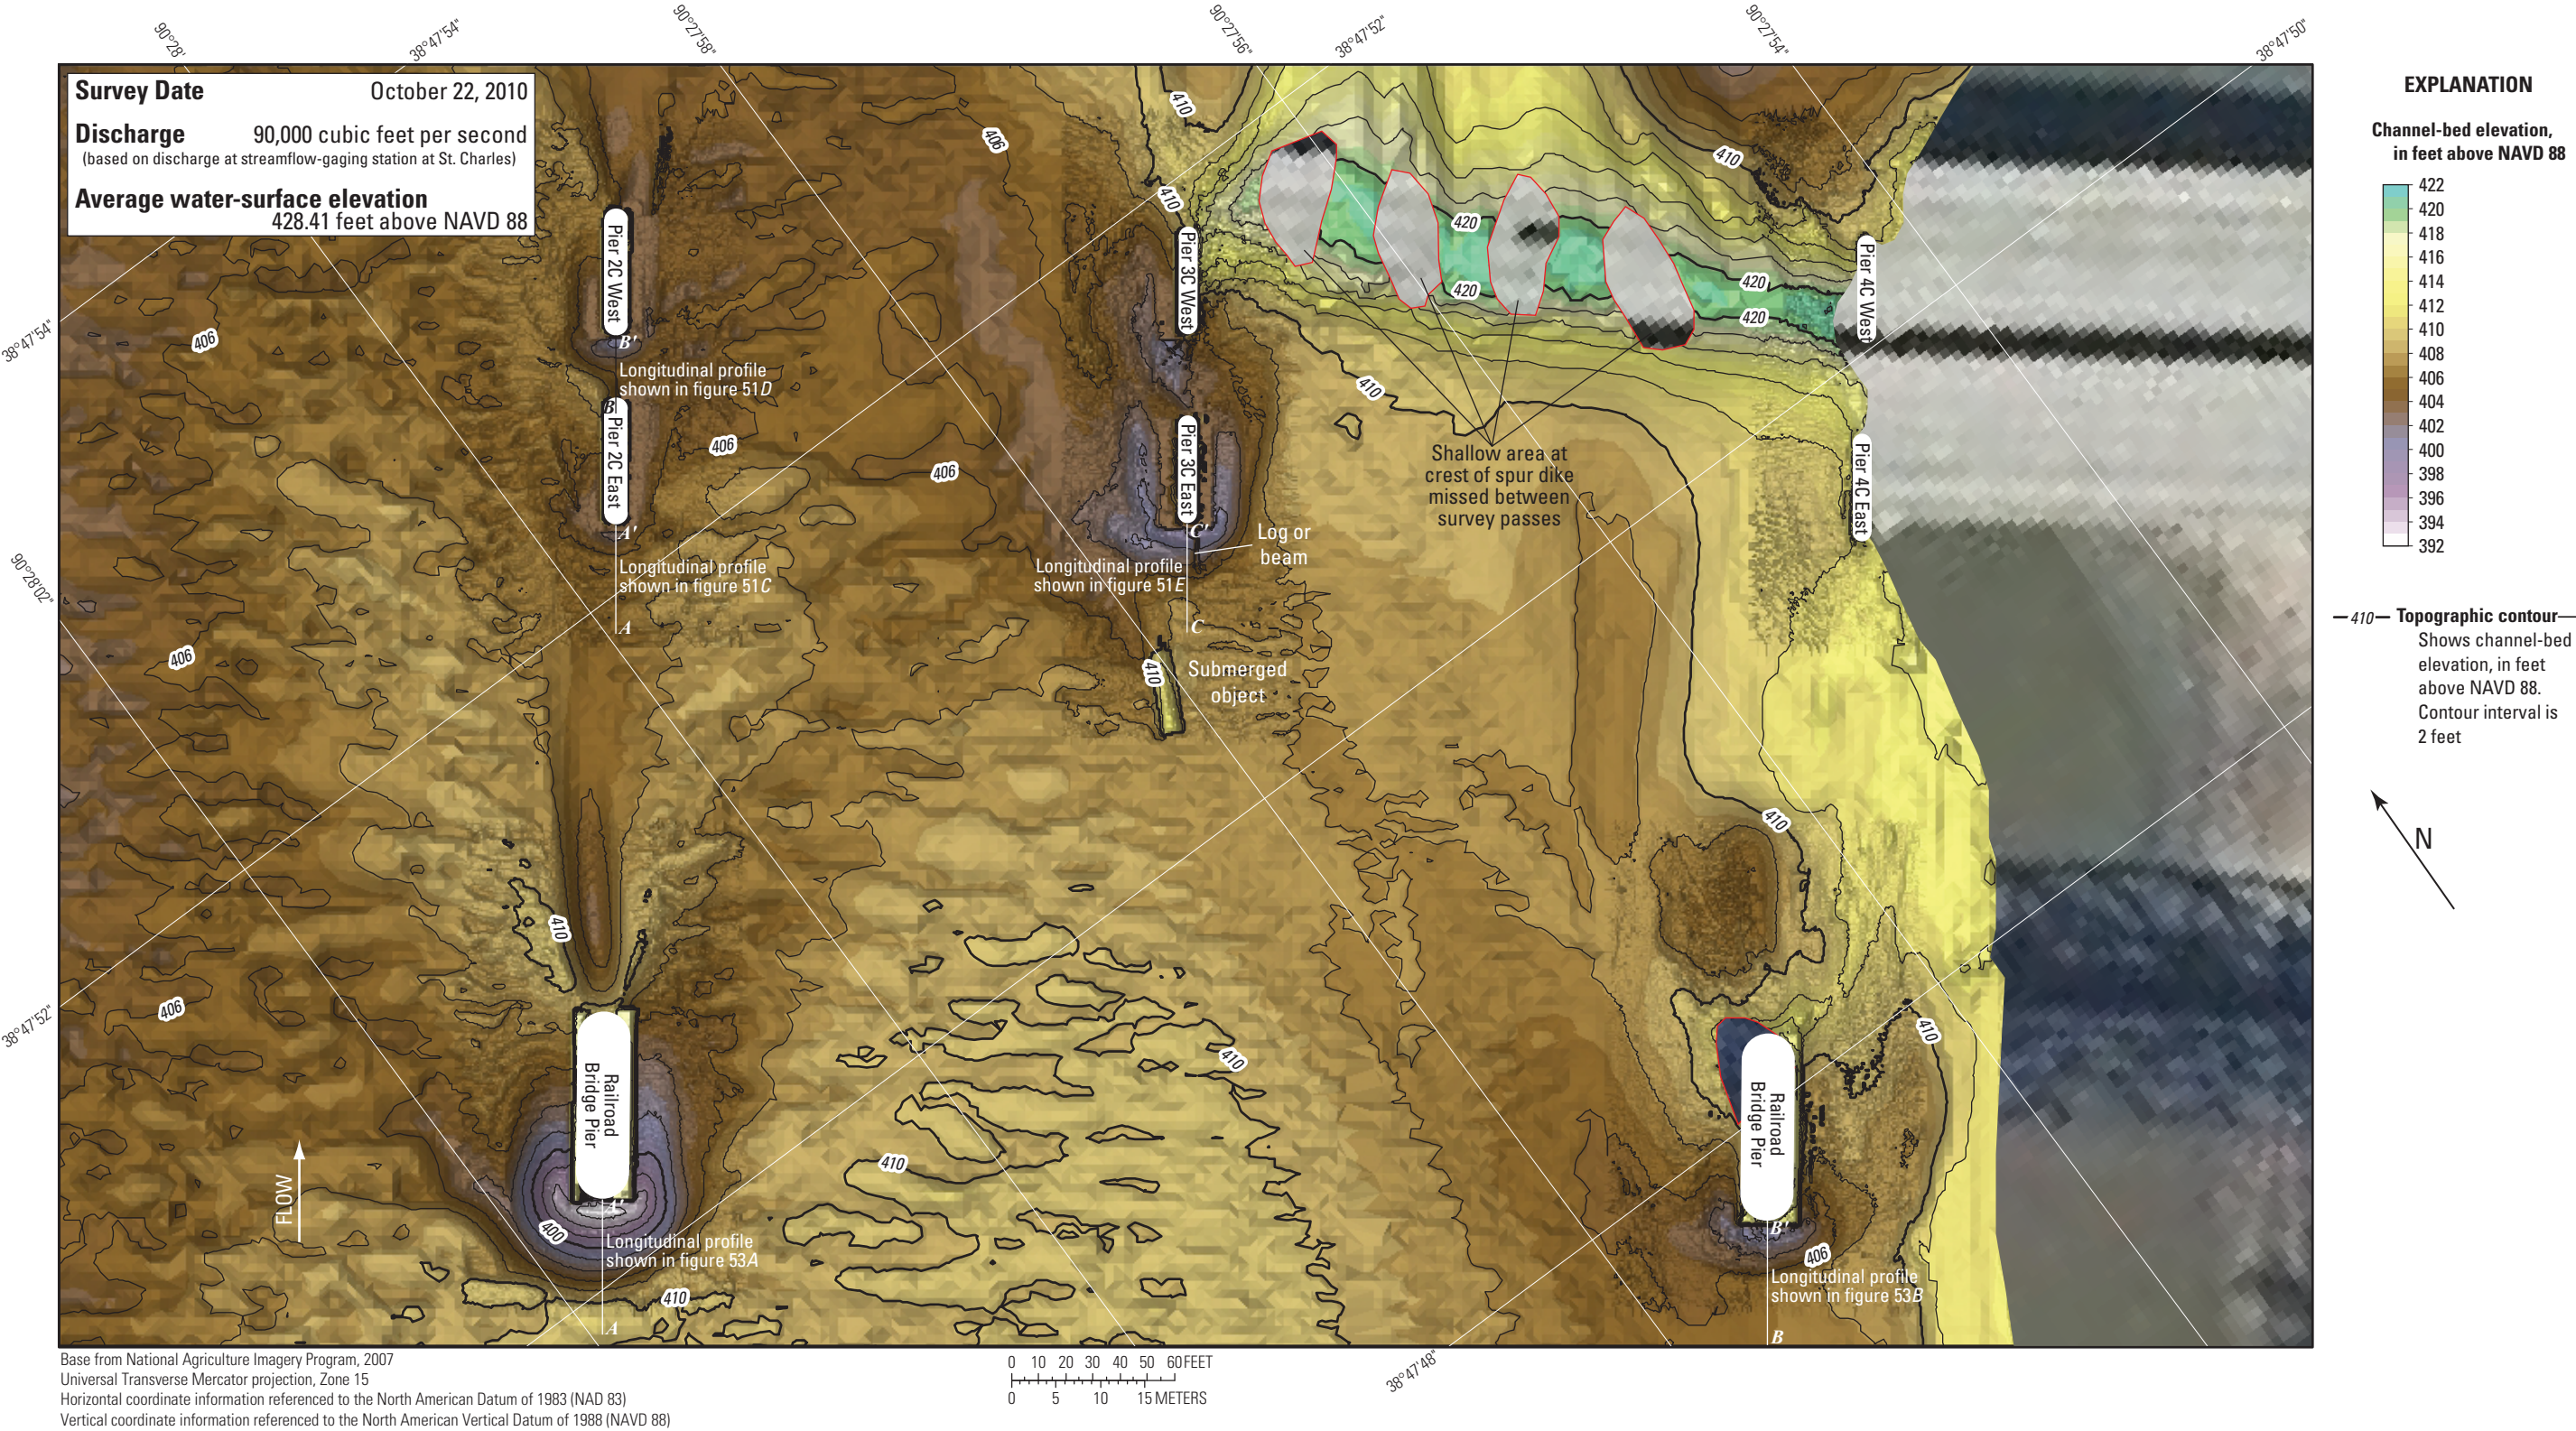
Figure 24. Bathymetric survey of the Missouri River channel in the vicinity of the main channel piers of dual bridge structure A4557 on State Highway 370 near St. Louis, Missouri.

A substantial scour hole was observed at the railroad bridge pier upstream from pier 2C (fig. 24). The hole had a minimum elevation of 393 ft at the nose of the pier, about 17 ft below the average channel bed immediately upstream from the pier (fig. 24). A smaller scour hole also was present at the railroad bridge pier upstream from pier 4C, which had a minimum elevation of 402 ft at the nose of the pier, about 5 ft below the average channel bed immediately upstream from the pier (fig. 24). The scour holes at the railroad bridge piers did not appear to affect the scour at piers 2C or 4C of structure A4557 (fig. 24).
